# **Test Report**

# ANSI/CAN/UL9540A

# Test Method for Evaluating Thermal Runaway Fire Propagation in Battery Energy Storage Systems

# [Unit Level]

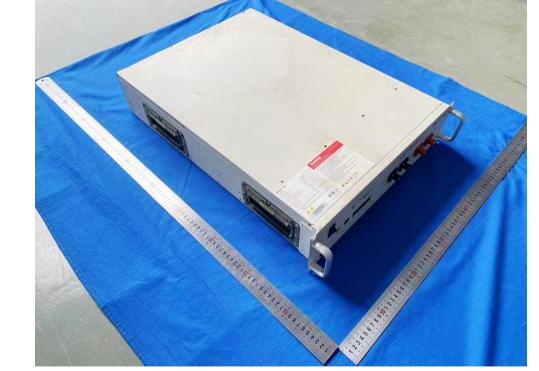
#### Figure 2a. External view of battery module

Model:	E-BOX 48100R		
Manufacturer:	Shanghai PYTES Energy CO., Ltd.		
Nominal capacity:	100 Ah		
Nominal voltage:	51.2 V		
Maximum charge current:	50 A		
Maximum discharge current:	50 A		
Maximum charge voltage:	58 V		
Cut-off Voltage:	47.5 V		
Charge temperature range:	0°C to 45°C		
Discharge temperature range:	-10°C to 50°C		
Unit configuration:	16S		
External dimensions:	440mm*620mm*117mm		
Enclosure material:	Iron		
Weight:	Appr. 51Kg		
UL 1973 compliant:	Yes / 🗌 No	Reference: TÜV SÜD Certif. No.: U10 003364 0009 Rev.01	
UL 9540A report provided:	🛛 Yes / 🗌 No	Reference: Report No. CQES230800040401 issued by SGS

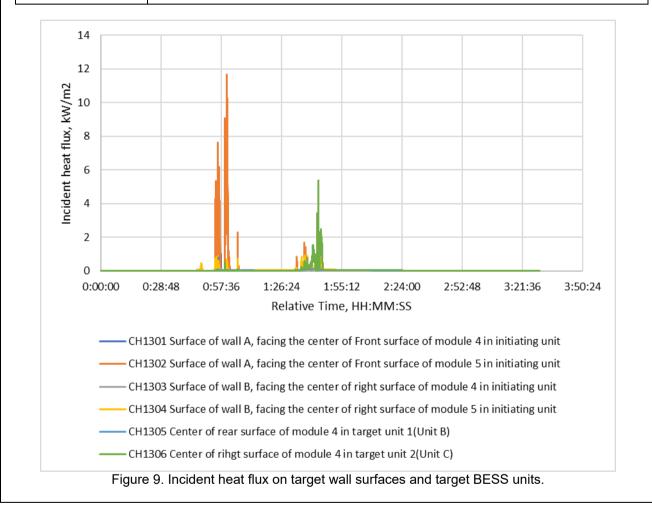
Maximum incident heat flux on target units and wall surfaces				
R	Result:				
	Heat Flux Sensor ID	Description of location			
	CH1301 Surface of wall A, facing the center of front surface of module 4 in initiating unit				
	CH1302	Surface of wall A, facing the center of front surface of module 5 in initiating unit			
	CH1303	Surface of wall B, facing the center of right surface of module 4 in initiating unit			
	CH1304	Surface of wall B, facing the center of right surface of module 5 in initiating unit			
	CH1305	Center of rear surface of module 4 in target unit 1(Unit B)			
	CH1306	Center of rihgt surface of module 4 in target unit 2(Unit C)
